# City of Baltimore Wet Weather Consent Decree Smoke and Dyed Water Testing Form

Sewershed : Gwynn Falls

Manhole ID : S0500\_013MH

Test ID : S1032-021013

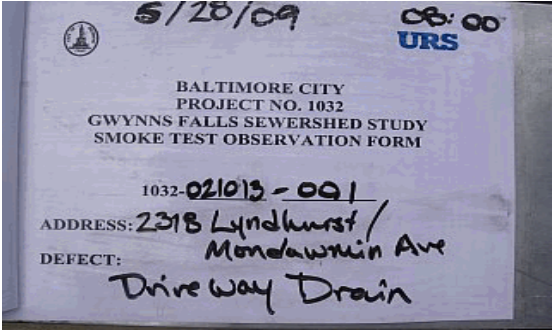
<p>Location: N/A; Type: Driveway Drain; Smoke: Heavy; Status: Private Property</p> </div> <div> <div>Landscape</div> <div>

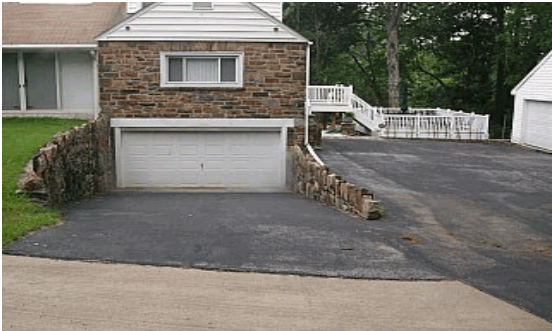
</div> <div> <div>Defect.</div> <div>   </div> </div> </div> </div>
